Case Study

Reliable Headworks Screening = Process Efficiency

Vermillion OH WPCF

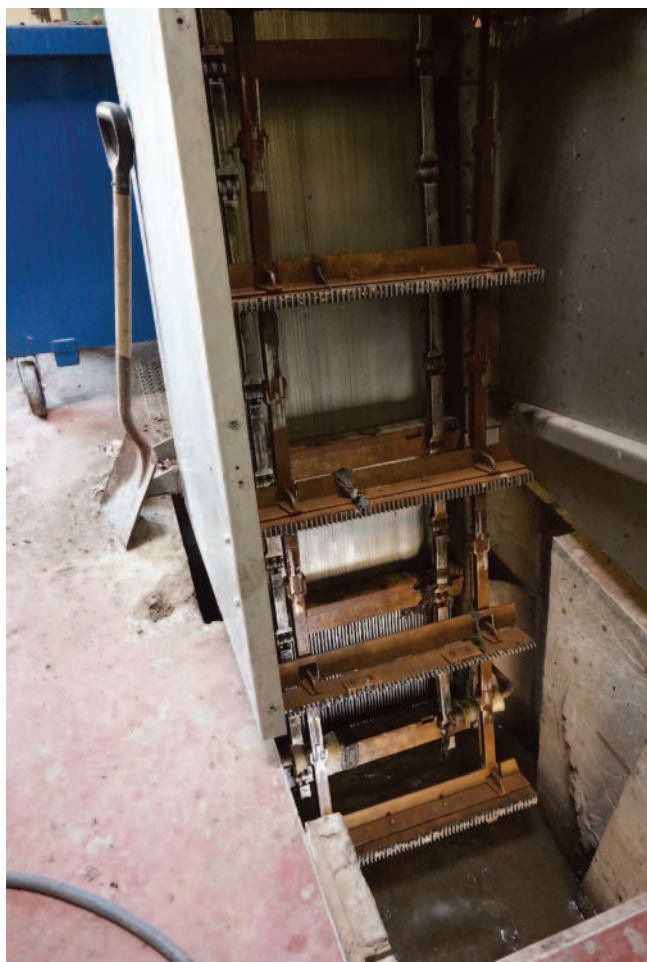
Channel modifications were required.

notched out so the rake would clear. Plus there was very little clearance to get the screen into the channel.

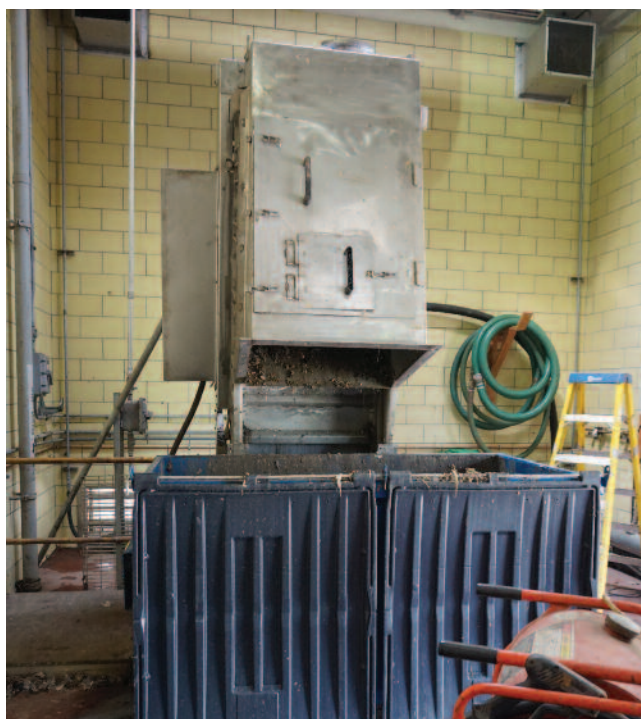
Thanks to the Lock Link screen,
a 3 cubic yard dumpster replaced the bucket.

Since the Lock Link was installed, the two clarifiers have been cleaned and are operating efficiently. They are about to rebuild a third clarifier which would allow them to accept more septage. The Superintendent purposely ordered the 0.25" bar spacing which he considers to be a fine screen. His goal was to capture as much debris as possible and not let it overload his clarifiers. The bucket has now been replaced with a 3 cubic yard dumpster which is emptied weekly.
